# Assessment of Dam Safety Coal Combustion Surface Impoundments (Task 3) Draft Final Report – Version 1

Georgia Power
Company
Plant Bowen

Cartersville, Georgia

September 14, 2009

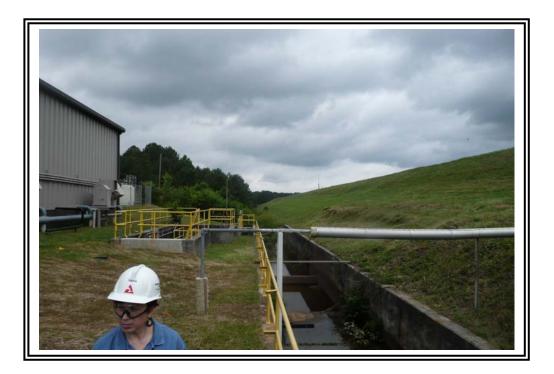
South end of main dike at NPDES Sampling flume, looking west. The majority of the slope shown is a natural cut slope, 5 to 10 foot high embankment constructed to blend into slope in this area.

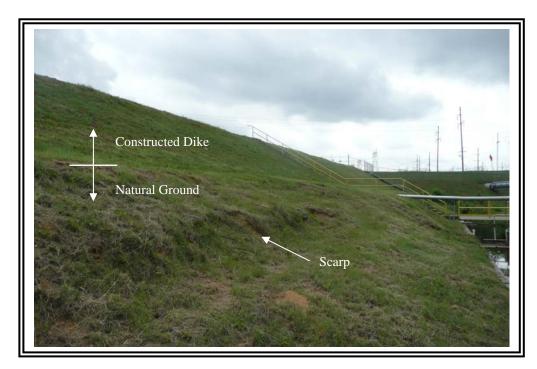
South end of main dike at NPDES sampling flume, looking east. Scarp in natural cut slope, reportedly unchanged in 6 to 10 years per Georgia Power Engineer responsible for inspections.

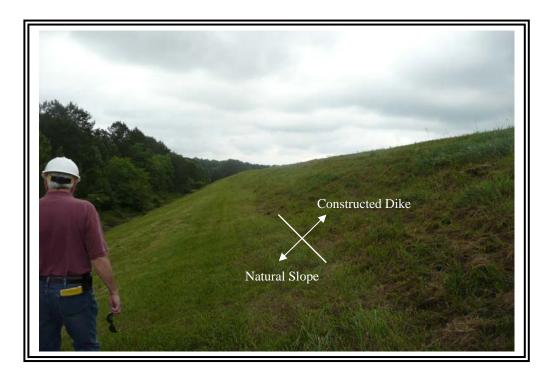
South end of the main dike, looking west. Note transition between natural cut slope and raised dike.

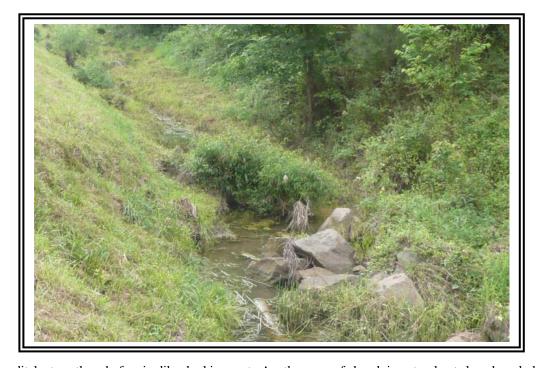
Perimeter ditch at south end of main dike, looking east. Another area of slough in natural cut slope has choked the channel and has reportedly remained unchanged in 6 to 10 years per Georgia Power Engineer responsible for inspections.

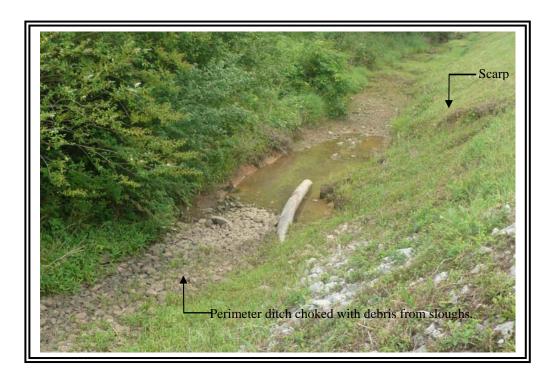
Perimeter ditch at south end of main dike, looking west, 180 degree view of previous photo.

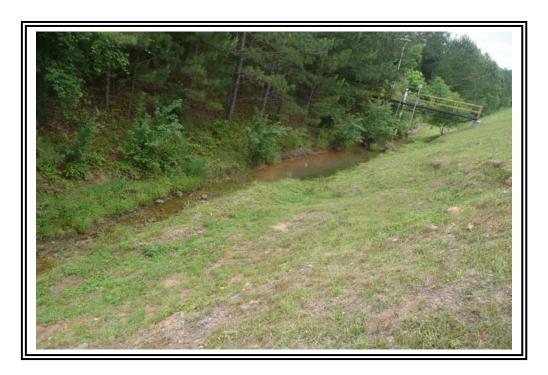
Continuing west on south end of main dike, another slough area in the natural cut slope, reportedly unchanged in 6 to 10 years per Georgia Power engineer responsible for inspections.

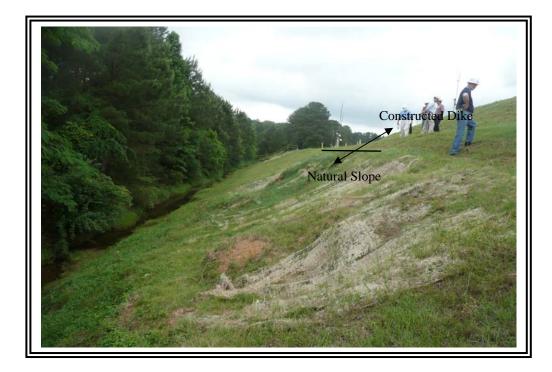
Continuing west on south end of main dike, another slough area in the natural slope reportedly unchanged in 6 to 10 years per Georgia Power engineer responsible for inspections. This area reportedly has had a difficult time re-establishing grass growth so more recent efforts included placing erosion matting.

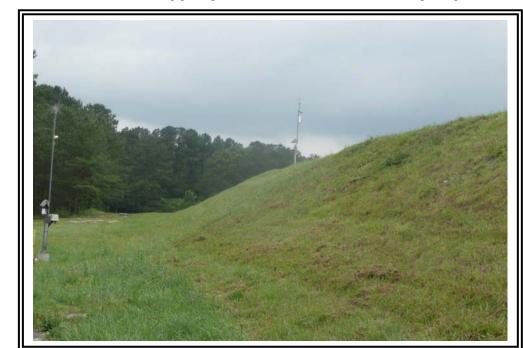
South portion of the embankment near the end of the recycle water portion of the impoundment, looking west. Recycle Pond is lined. Note set up for remote monitoring of piezometers (not operational as of our visit).

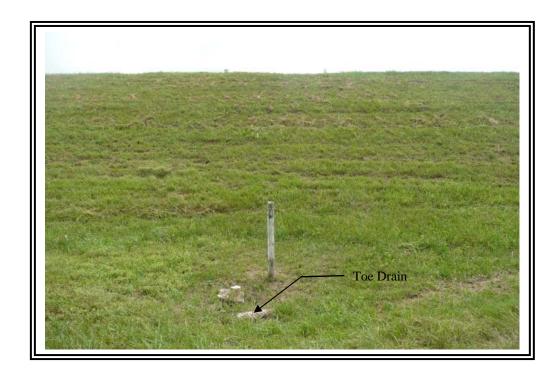
South end of the west portion of the Dike. Toe drain outlets are marked with concrete posts. Toe drain outlets located about every 200 feet. No flow noticed, and Georgia Power indicates they have not seen water flowing in the toe drain.

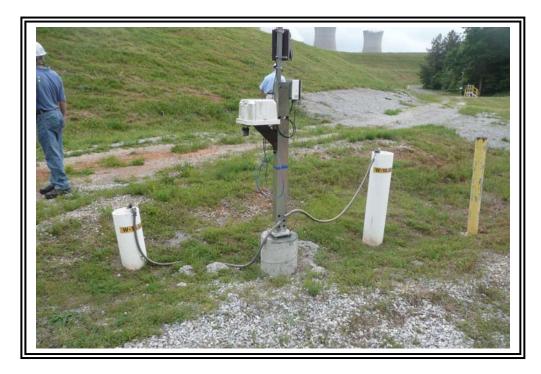
Embankment at the "Horseshoe" (looking south). Note the gravel at the toe which was placed during the grouting program to seal karst features below the embankment.

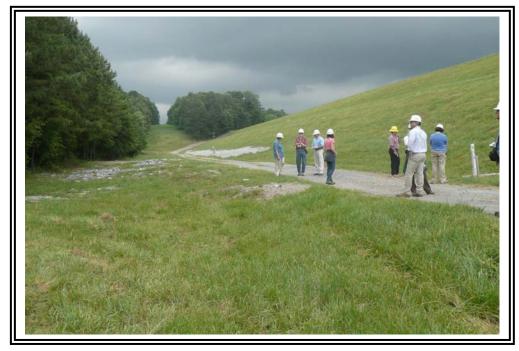
North end of Main Dike (looking north). Note: The gravel at the toe which was placed during the grouting program to seal karst features below the embankment.

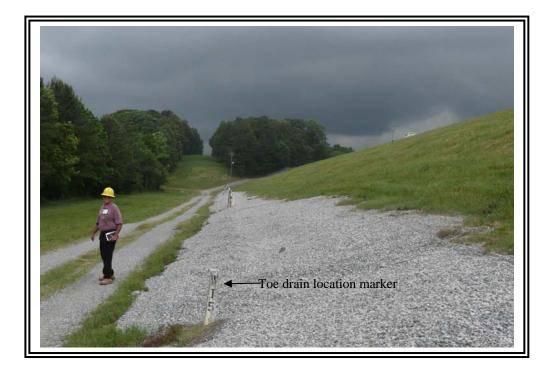
Stone cover at North end of Main Dike placed during the grouting program to seal karst features below the embankment. The white numbered concrete posts mark toe drain locations.

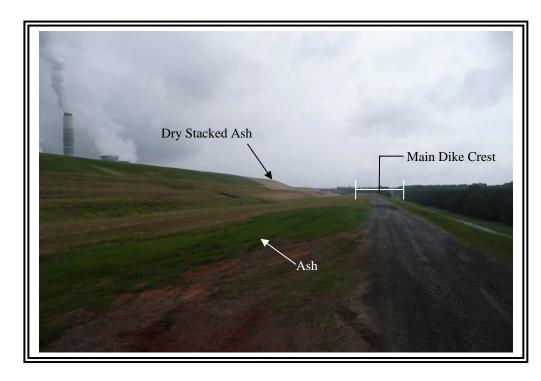
Main Dike Crest, looking south. Note: Dry ash stack area in the left of the photo, original embankment crest width 15 feet. Drainage swale is located between the dam and the dry stacked ash pile.

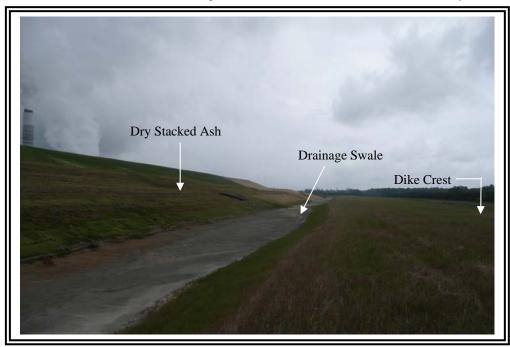
Drainage swale between dike and dry stacked ash piles.

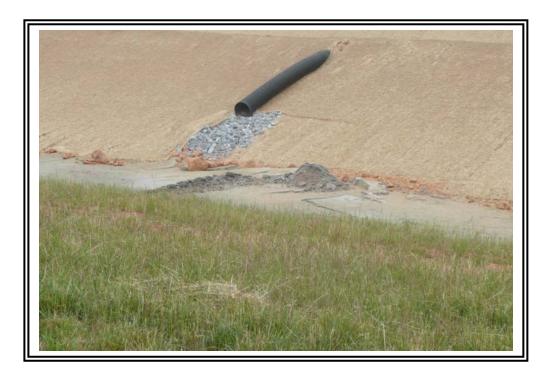
Surficial drainage system draining storm water runoff from ash stacks to the drainage swale.

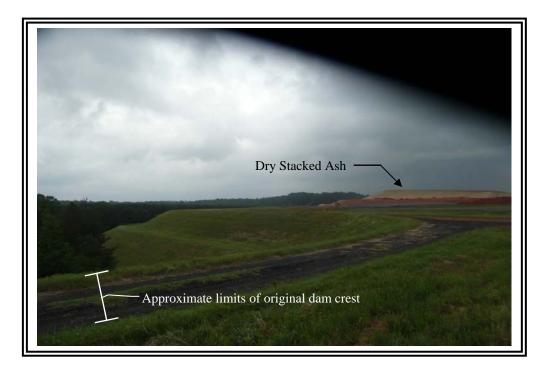
Embankment at the "Horseshoe", looking north. Note original embankment crest width was 15 feet. Cover soil placed uniform to dike crest.

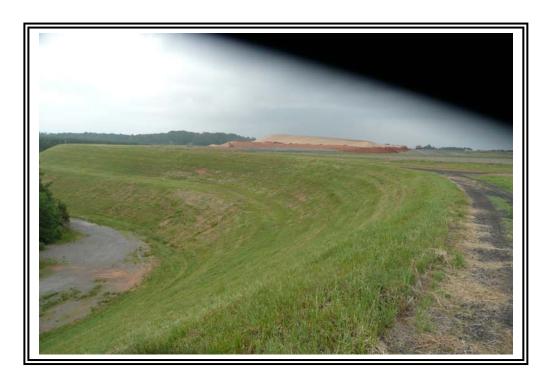
Embankment at the "Horseshoe", looking north. Gray coloring at toe of embankment is gravel placed along the road.

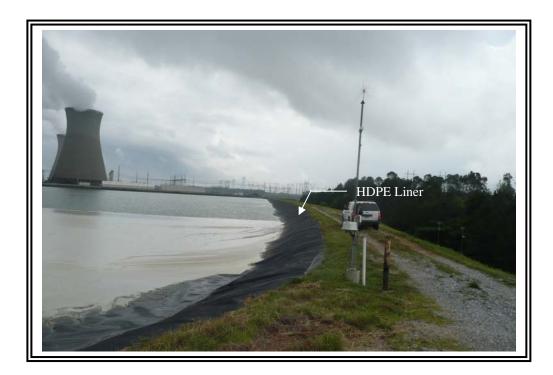
Recycle Pond and south end of the embankment crest looking east.

Note the Recycle Pond is lined with bentonite and HDPE liner.

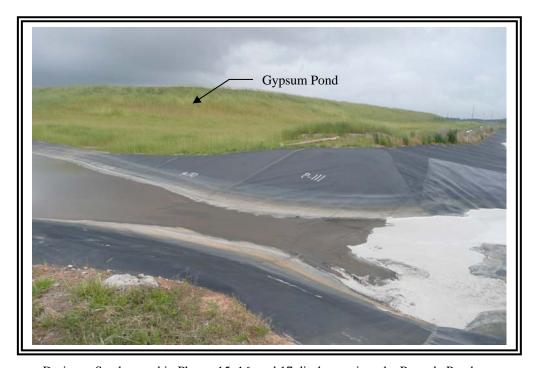
Drainage Swale noted in Photos 15, 16, and 17 discharges into the Recycle Pond. Note the drainage swale is also HDPE lined. Behind the swale in this photo is one of two gypsum ponds.

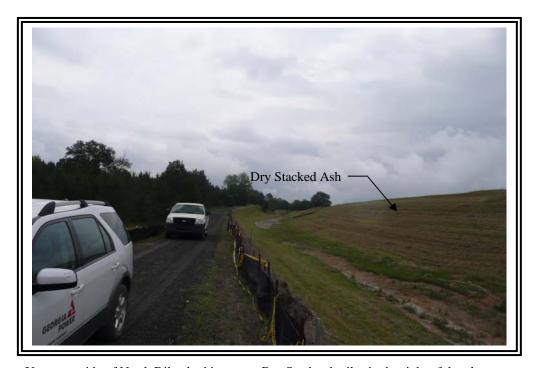
Upstream side of North Dike, looking east. Dry Stack ash piles in the right of the photo. Drainage swale in this area is lined with clay, but additional work is planned for the 2009 construction season.

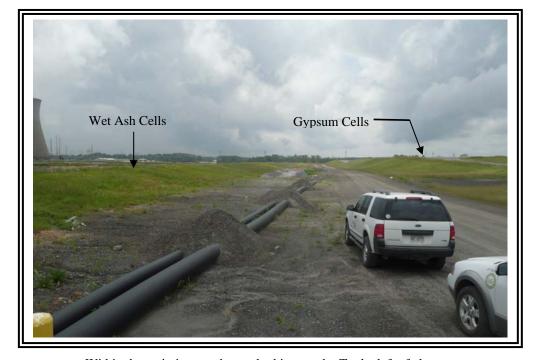
Within the main impoundment, looking south. To the left of photo are the ash dewatering cells (2) and to the right of the photo are the gypsum dewatering cells (2).

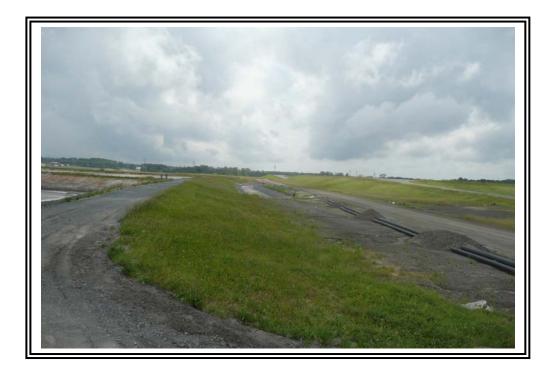
The west embankment of the ash dewatering cell. Note short height and 3H:1V slope.

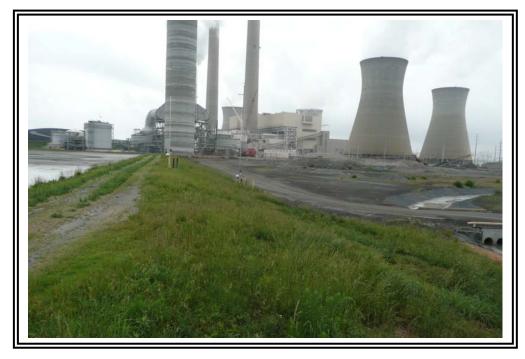
South embankment of ash dewatering cells, looking east. Note the lined drainage swale in right of photo discharges into the recycle pond.

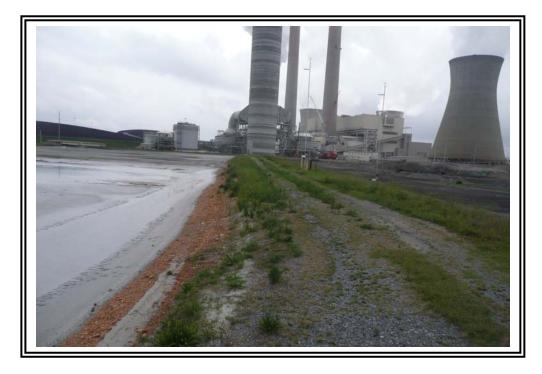
Upstream slope of south embankment of ash dewatering cells, looking east. Note the red clay liner which overlays a liner.

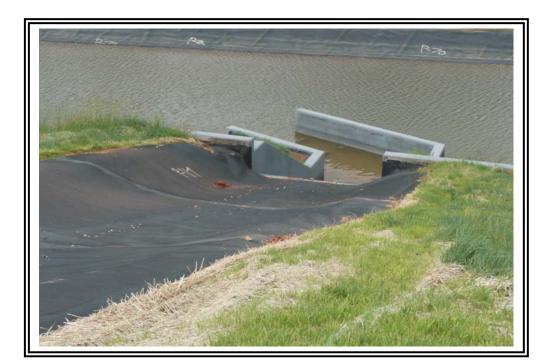
Emergency overflow and outlet sluice (via buried outlet pipe) from the gypsum dewatering cell into the drainage swale running to the recycle pond.
